## STABILITY ANALYSIS OF THE BUTTAHATCHEE RIVER BASIN, MISSISSIPPI AND ALABAMA

USDA-ARS National Sedimentation Laboratory Report Number 50

**Mississippi Department of Environmental Quality**

**November 2005**

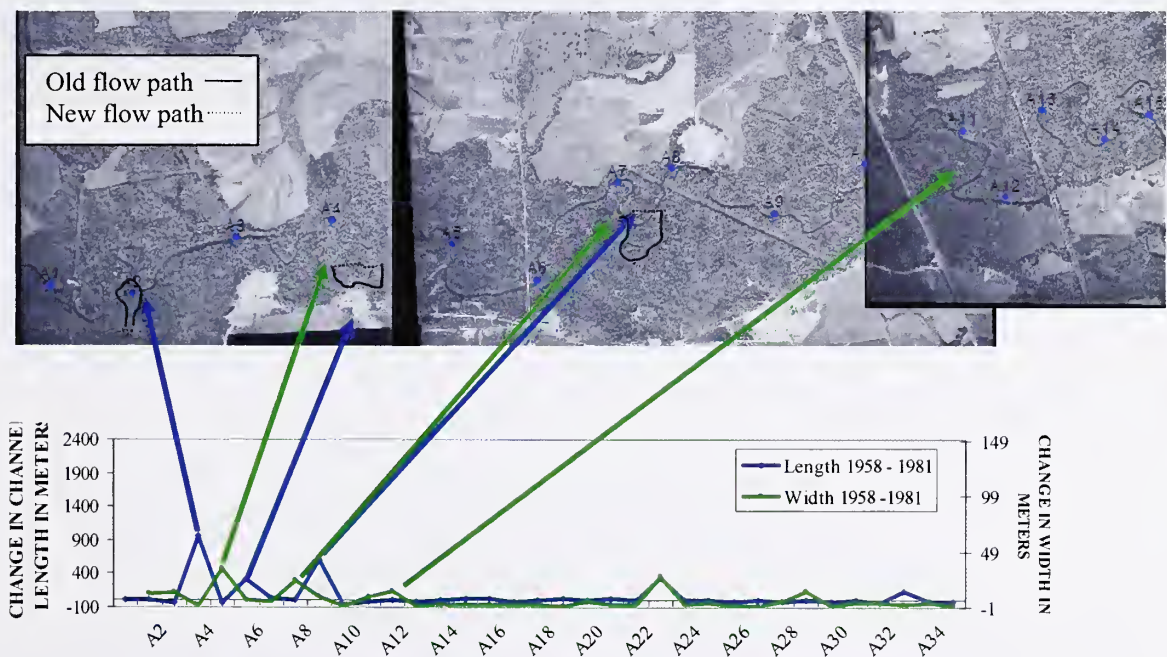
**Widening and length changes: 1958 to 1981:** Channel width and length changes in this time period were predominantly attributable to meander cutoffs occurring in Reach A. During this time period four cutoffs occurred in Reach A (between A2 and A3, A4 and A5, A7 and A8, and at A22; Figure 12), with an associated decrease in channel length totaling approximately 2.3 km (approximately 9 % of the channel length from the old river mouth to the upstream location of the cutoff at A22).

**Figure 12 – 1958 air photos with accompanying graph highlighting the locations of meander cutoffs and associated channel length width changes between 1958 and 1981 air photos.**

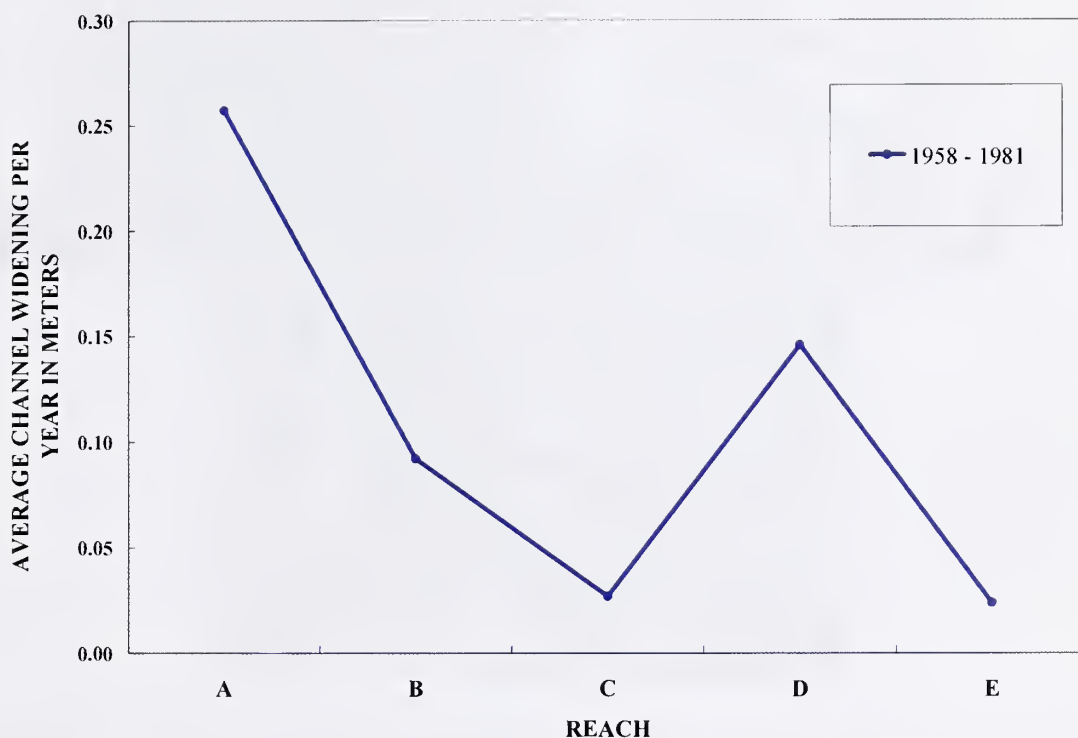
The average widening rate in reach A of the Buttahatchee River was higher than the other reaches during this time period ( $A = 0.23$  m/yr) as a response to the meander cutoffs seen in the air photographs. Lower average widening rates occurred throughout the rest of the river during this period ( $B = 0.09$  m/yr,  $C = 0.03$  m/yr,  $D = 0.15$  m/yr,  $E = 0.02$  m/yr), although small peaks on Figures 23 and 24 do show localized erosion at some sites. The widening rates show a general attenuation in channel response moving away from reach A, where most of the disturbances to the channel have been concentrated. The exception to this trend is the rate of widening seen in reach D (Figure 15).

**Figure 15 - Average widening rates for each reach taken from 1958-1981 air photos.**

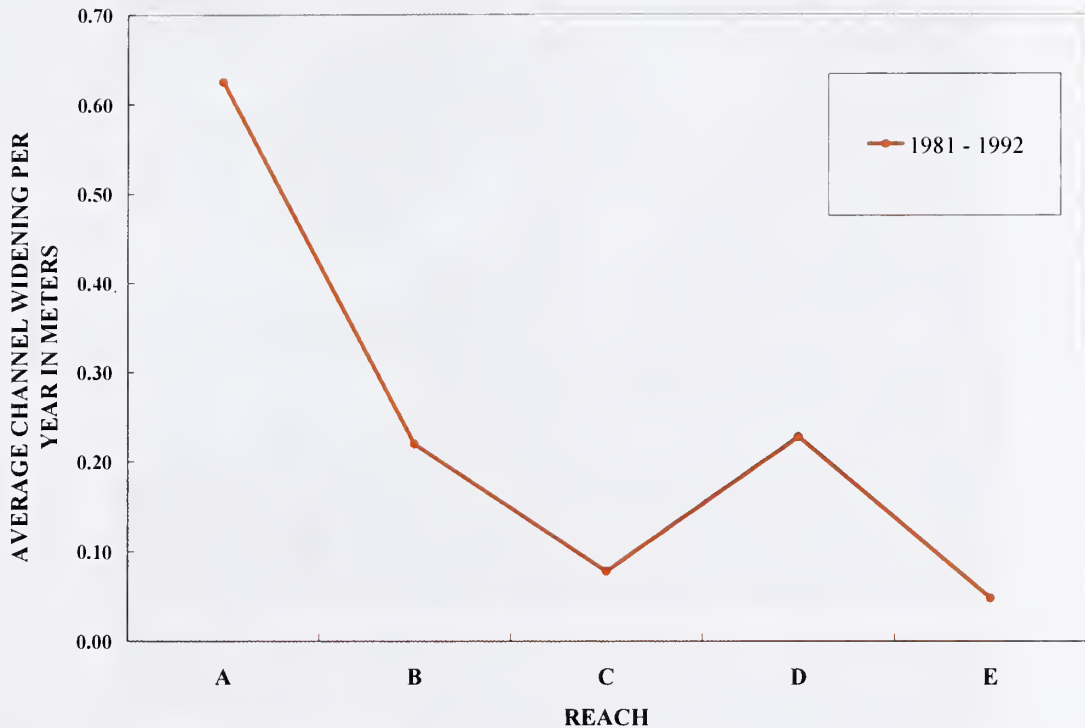
Average widening was 0.63 m/yr for reach A, 0.22 m/yr for reach B and 0.08 m/yr for reach C from 1981 – 1992 (Figure 19), compared to average widening rates of 0.23, 0.09 and 0.03 m/yr respectively for the 1958-1981 time period (Figure 15). Average widening rates can be seen to decrease from reach A to reach C; the disturbances to the river in the A reach, caused by TTW construction and gravel mine capture and ponding has had the greatest effect during this time period at sites in the vicinity of the disturbances. However, erosion during this time period was observed as far upstream as reach C, in

**Figure 19 - Average widening rates in each reach taken from 1981 - 1992 air photos.**

The average widening rate in reach D was at its highest during the period 1981-1992 (Figures 19 and 27). Analysis of the air photography shows that sometime between the 1981 and 1992 images, a large area of land was logged on the east bank of the river between rkm's 117 and 118. The area of logging extended right up to the bank edge, and was accompanied by a grade control structure and check dam. Other areas of land clearance are also visible in this reach on the aerial photography (Figure 20).

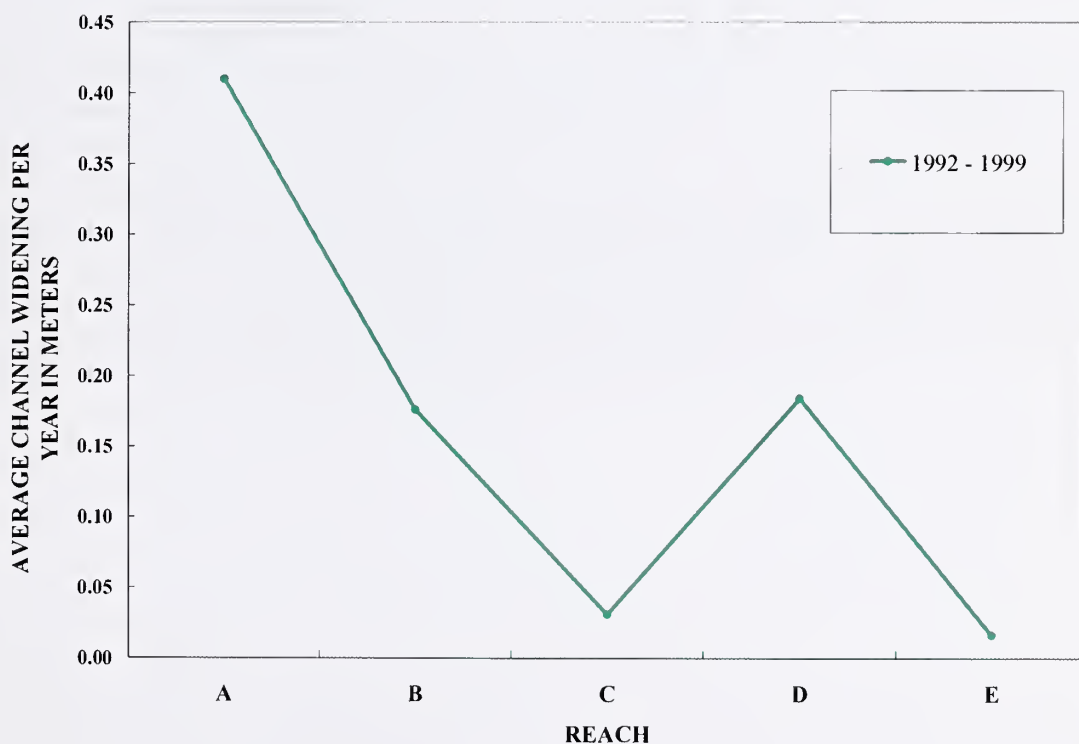
**Widening and length changes: 1992 – 1999:** Analysis of air photos for the period 1992 to 1999 showed the lowest average annual rates of bank widening for any of the time periods studied. Bank widening rates were lower for all reaches during these years, averaging 0.41 m/yr for reach A, 0.18 m/yr for reach B, 0.03 m/yr for reach C, 0.18 m/yr for reach D and 0.02 m/yr for reach E (Figure 21). The highest rate of widening was still in reach A, and the 1992-1999 graph in Figure 24 shows that most of the changes in width during this period were concentrated in reach A, and the lower 10 km of reach B. Significant instability still seems apparent in reach A during this time period. Rates of widening in reach D were still noticeably higher than the upstream and downstream reaches during this time period, as the positive feedback between sediment deposition and bank erosion continued through this period of analysis. Changes in total channel length between 1992 and 1999 actually showed a slight trend towards increased channel length (Figure 26). This increased length was likely to be a result of the aggrading bars and extending meander bends occurring not only in reach D, but also in parts of the lower reaches. In the lower reaches the energy imbalance between sediment input and the energy available to transport sediment was also evident from bar accretion and bank instability seen in the air photographs.

**Figure 21 - Average widening rates for each reach taken from 1992 - 1999 air photos.**

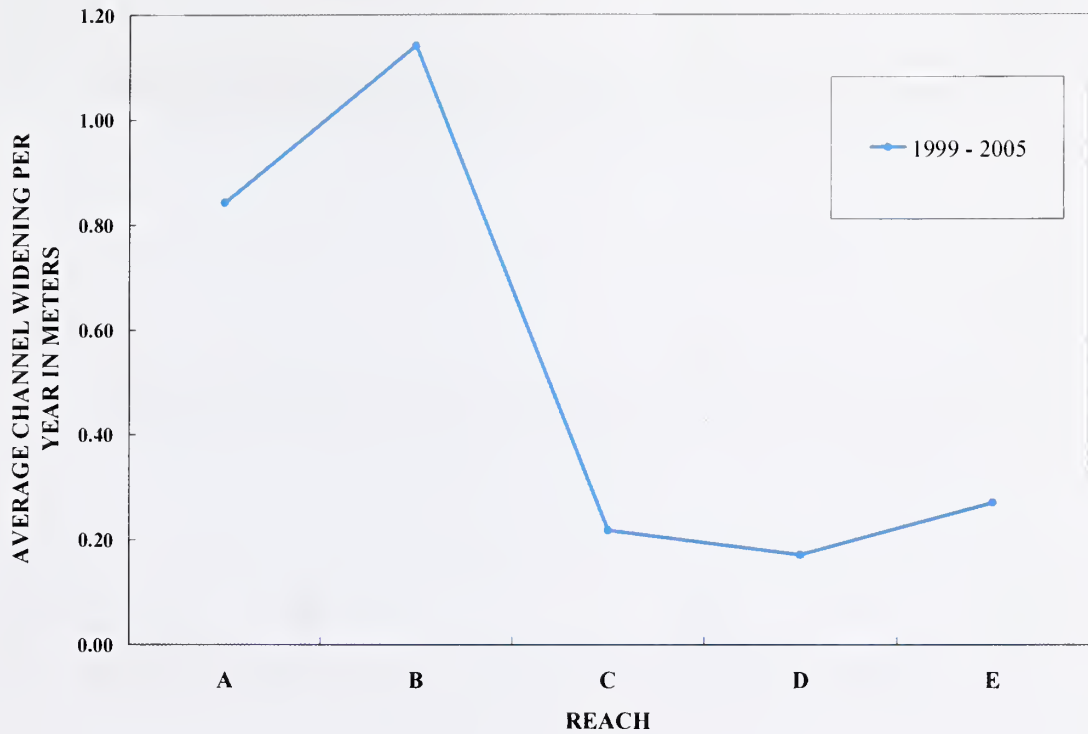
Average channel widening rates were 0.87 m/yr for reach A, 1.14 m/yr for reach B, 0.22 m/yr for reach C, 0.17 m/yr for reach D, and 0.27 m/yr for reach E (Figure 22). As stated above, calculation of the widening rates and amounts in this time period may have been affected by the differing methods for attaining widths. However, bearing in mind the high degree of instability noted both during the RGA's conducted from a boat in the river channel, and aerial reconnaissance from the helicopter flight, it does seem to be the case that the channel is currently unstable along large portions of the 172 km studied. The upper part of reach A and lower part of reach B seem to be the most unstable in this period of analysis (Figure 22). It is also interesting to note from Figure 22 that more widening is taking place in reach B in this time period than in reach A. It is possible that channel instability is moving upstream over time as the channel's response to the gravel mine capture (A10) in the late 1980's slowly migrates upstream. In addition, the average rate of widening in reach D seems to be lower in this last time period, with rates of widening however increasing in the reaches upstream of the D reach.

**Figure 22 - Average widening rates for each reach taken from 1999 air photos and 2005 field data.**

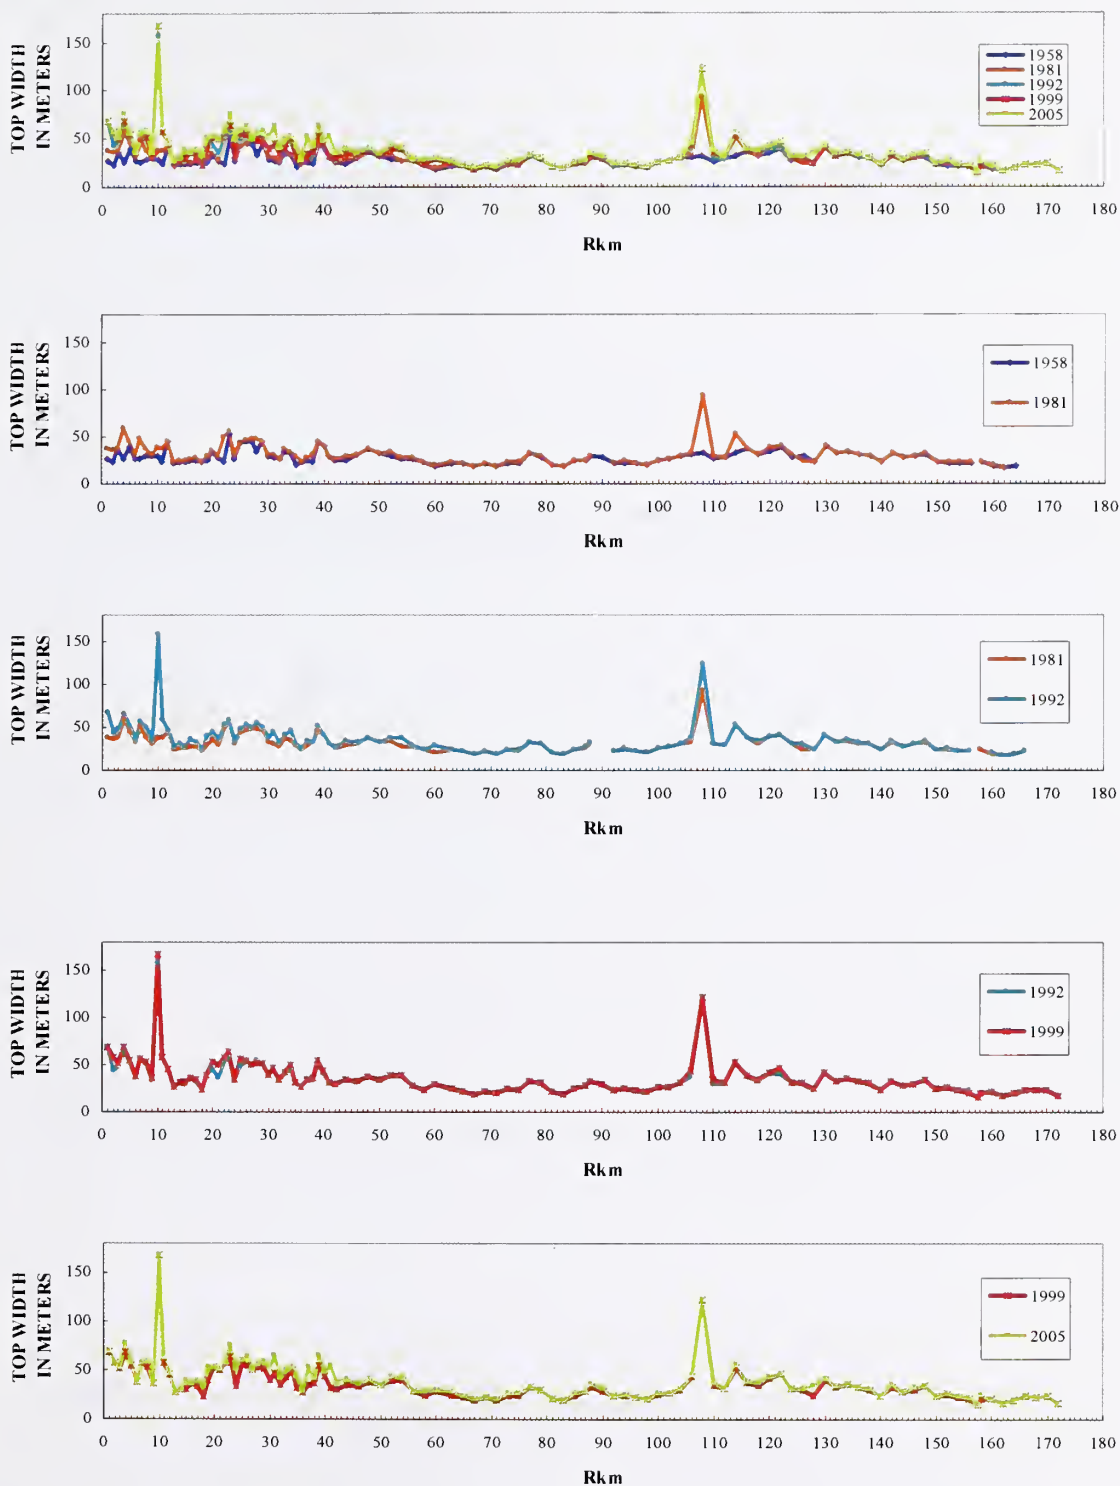
**Figure 23 – Channel top-widths measured from air photos (1958 – 1999) and in the field (2005).**

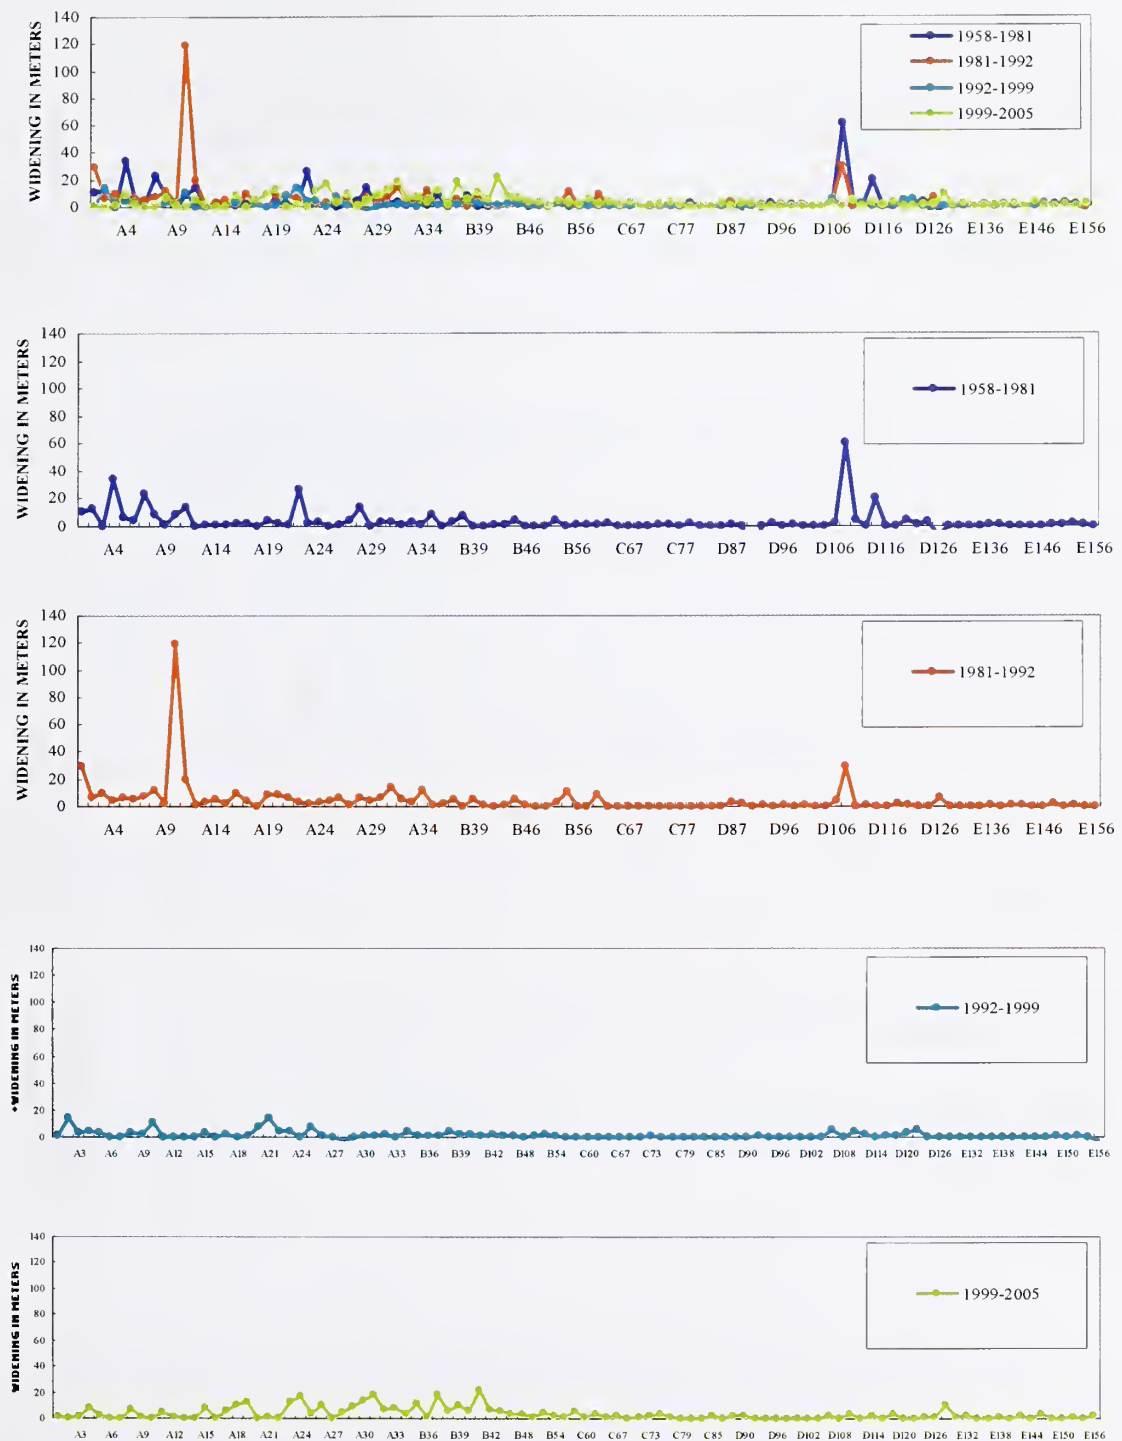
**Figure 24 – Changes in channel top-widths measured from air photos (1958 – 1999) and in the field (2005).**

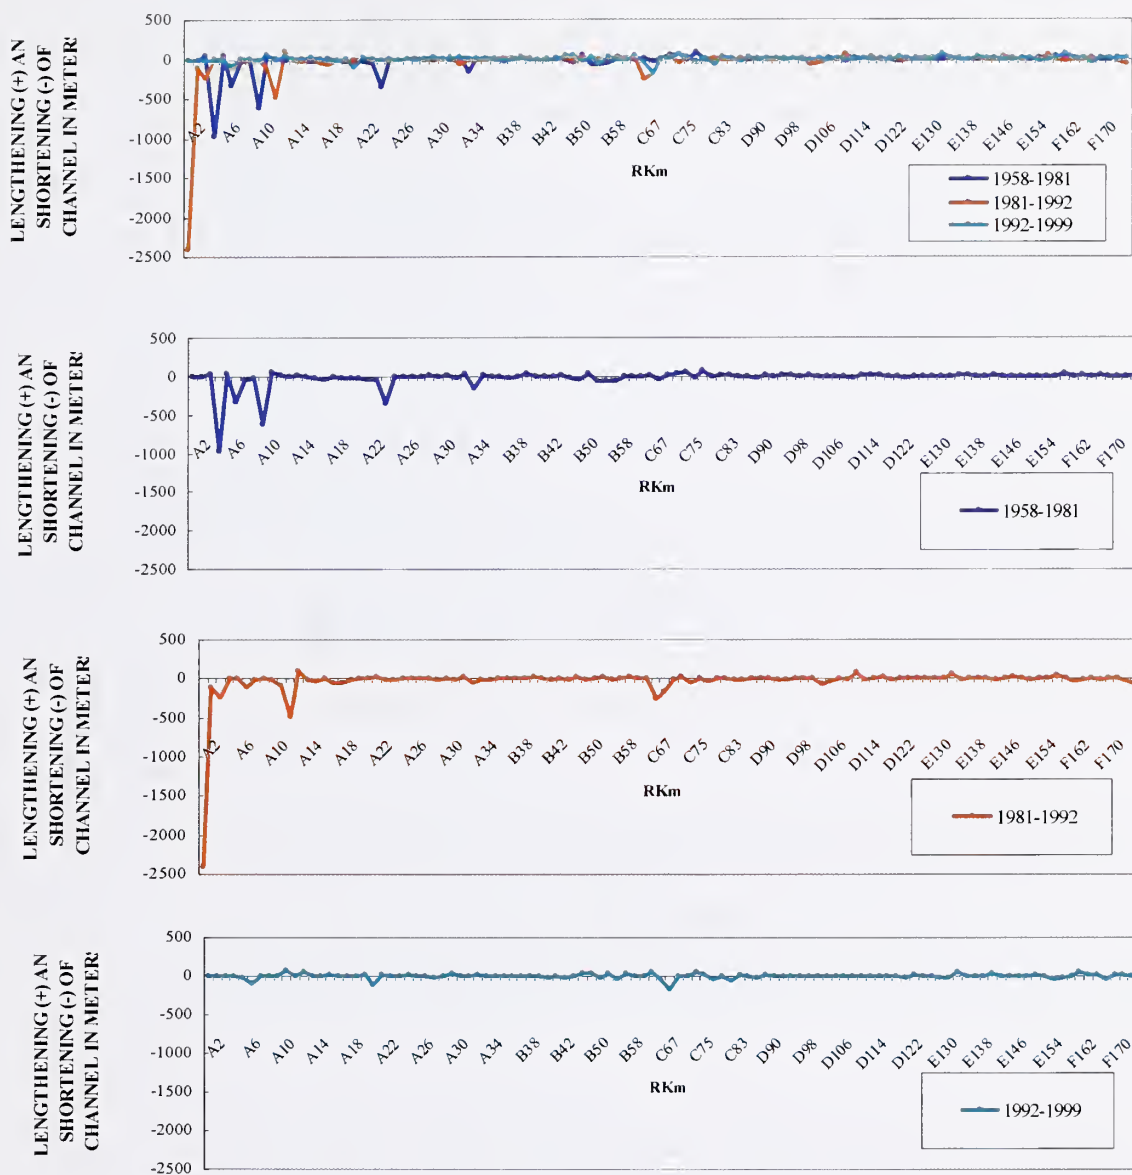
Figure 25 – Changes in channel length measured from air photos (1958 – 1999).

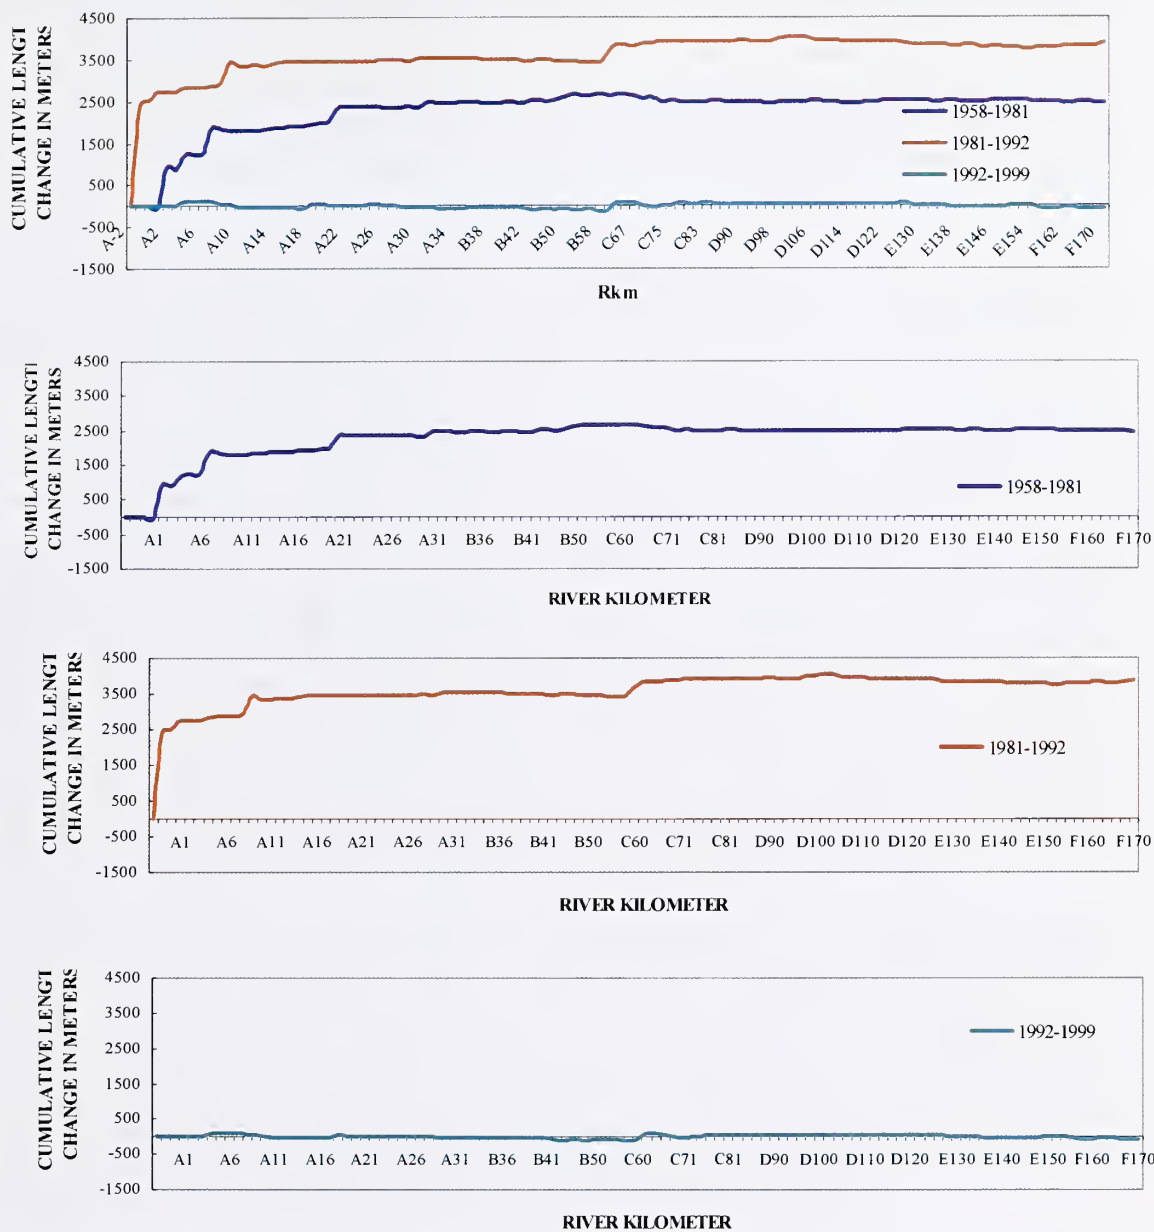
General widening occurred through the whole of reaches A and B and into the lower section of Reach C between 1981 and 1992. There was also a decrease in channel length due to TTW construction, and gravel mine capture. Cumulative shortening for whole length of channel studied equaled approximately 4 km during this time period, the vast majority of which occurred in reach A (Figure 26).

**Figure 26 – Cumulative changes in channel length (shortening) measured from air photos (1958 – 1999).**

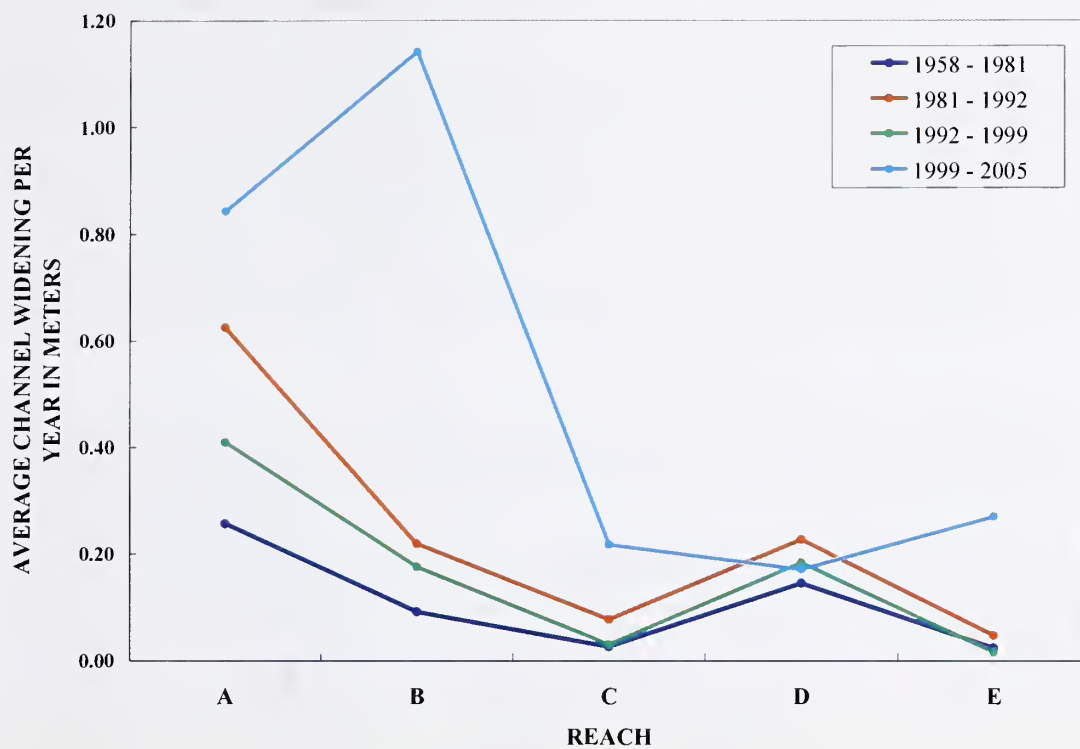
During the first three time periods of analysis it can be seen that there was a general attenuation in average widening rates moving upstream away from reach A, where most of the disturbances were concentrated. The exception to this trend is reach D, in which rapid rates of widening identified in the air photos are a result of channel migration related to excessive sediment emanating from logged areas and the close proximity of these activities and agricultural land-use to the river at some locations. This point is discussed in further detail in a later section on land-use (Section 5.2.5). The other noticeable trend is that in the last time period (1999-2005), the peak average rate of bank widening occurs in reach B, which supports the idea that the effects of disturbances that occurred in reach A are now migrating upstream into the higher reaches. The channel widening rates and instability shown in this section therefore seem to suggest that the Buttahatchee River is responding to two different areas of disturbance: first modifications to the A reach from TTW construction, gravel mine capture and meander cutoffs, and second, a positive feedback loop that has developed in the D reach as a result of excessive sediment delivery to the channel, leading to bar accretion and associated bank erosion at outer meander banks. Sediment delivered to the channel in the upper reaches may also be having a significant impact on processes occurring downstream, so not only are there channel responses moving upstream from the disturbances in reach A, but land-use issues and bank failures in the upper reaches are also affecting sediment transport and related channel forms and processes in the reaches downstream of the sediment sources.

**Figure 27 – Average rates of widening for each reach in each time period excluding mine ponding from average rates of widening.**

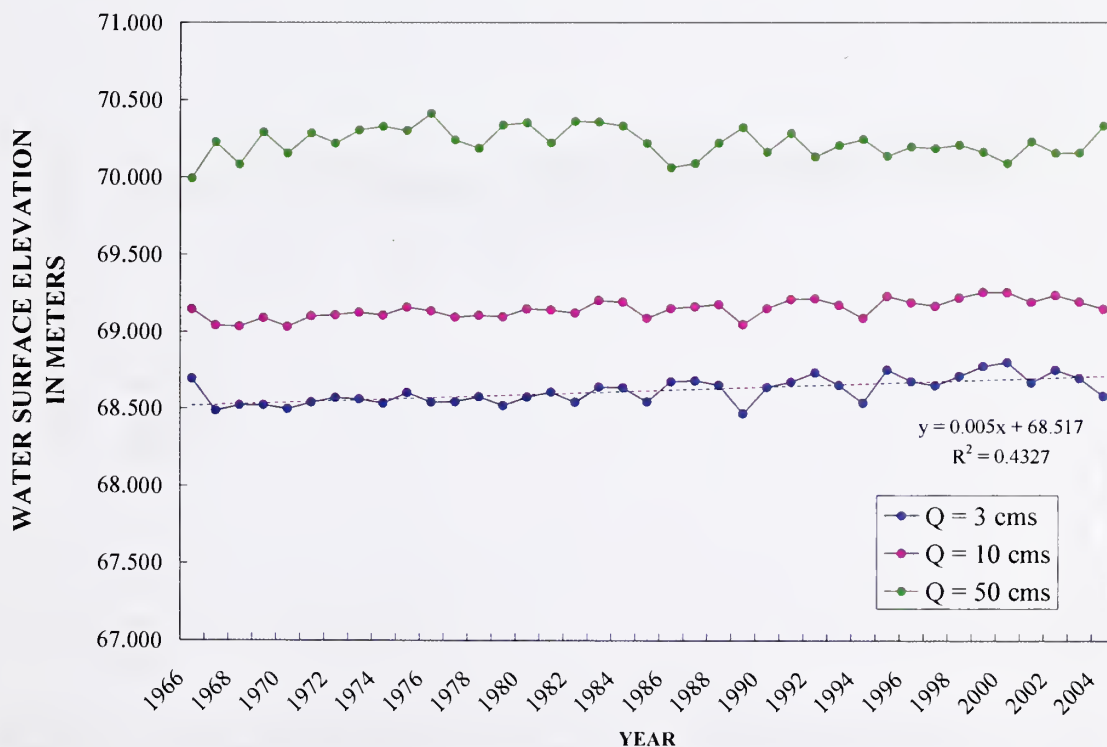
Specific-gage analysis at the Aberdeen gage shows an increase in the WSE at the two lowest discharges, indicating a consistent trend of mild aggradation (between 0.4 and 0.5 cm/y) over the period of record (Figure 28). At the higher discharge (50 m<sup>3</sup>/s) which includes any changes in channel width, the trend is reversed with WSE decreasing slowly with time. The decrease in WSE at this flow level result indicates that the channel was widening with time, notwithstanding the deposition occurring on the bed. This trend is

more pronounced if viewed in more detail. Note that between 1966 and 1976, WSE at  $50\text{m}^3/\text{s}$  was increasing, indicating more rapid channel filling, but that this trend was reversed in 1977. Because the analysis at the lower flows shows consistent aggradation, this seems to indicate that channel widening may have been initiated about this time. It is difficult to determine the exact cause and effect of these trends, however, the large flood flows of 1973 must have delivered large quantities of sediment to the river that was then eroded in subsequent years. This interpretation is supported by depth-discharge and width-discharge relations generated from USGS discharge-measurement data (Figures 29 and 30). The mid-1970's changes in channel depth and width shown in Figure 30 for a given discharge can be seen to have taken place prior to TTW completion but is coincident with the start of construction in the mid-1970's.

**Figure 28 – Specific gage analysis for 02439400 Buttahatchee River at Aberdeen 1966-2004.**

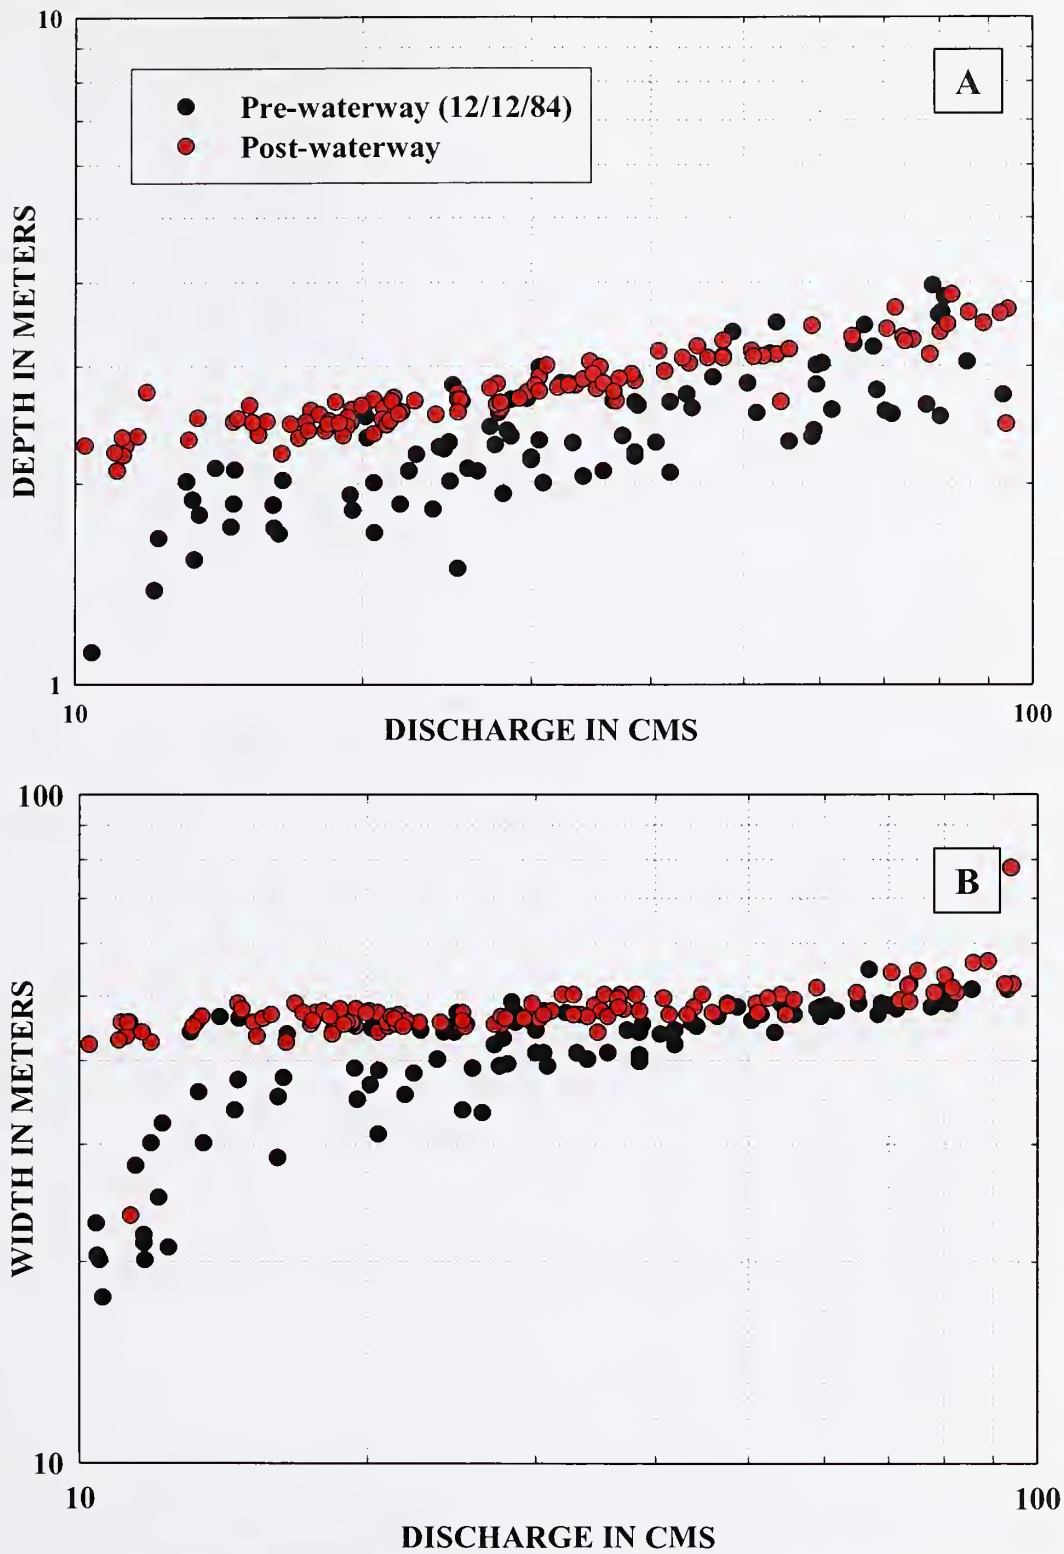
The data show that average flow depth for a specific discharge increased by approximately 0.5 m at the Aberdeen gage during the 1970's. This initially seems contradictory to the aggradation results shown in Figure 28, but appears to be the net result of preferential deposition on an inside bend causing narrowing of the flow area for medium discharges and hence, an increase in average flow depths. These processes cause an increase in the river's ability to transport sediment by enhancing stream power and average boundary shear stress. At a discharge of  $50\text{m}^3/\text{s}$  the increase in slope provided by the channel cutoffs in combination with the increase in hydraulic depth resulted in a 52% increase in average boundary shear stress at this flow rate.

Figure 29 – A) Discharge-depth relation and B) discharge-width relation for gage 02439400 Buttahatchee River at Aberdeen, with data separated into pre- and post-Tenn-Tom Waterway completion.

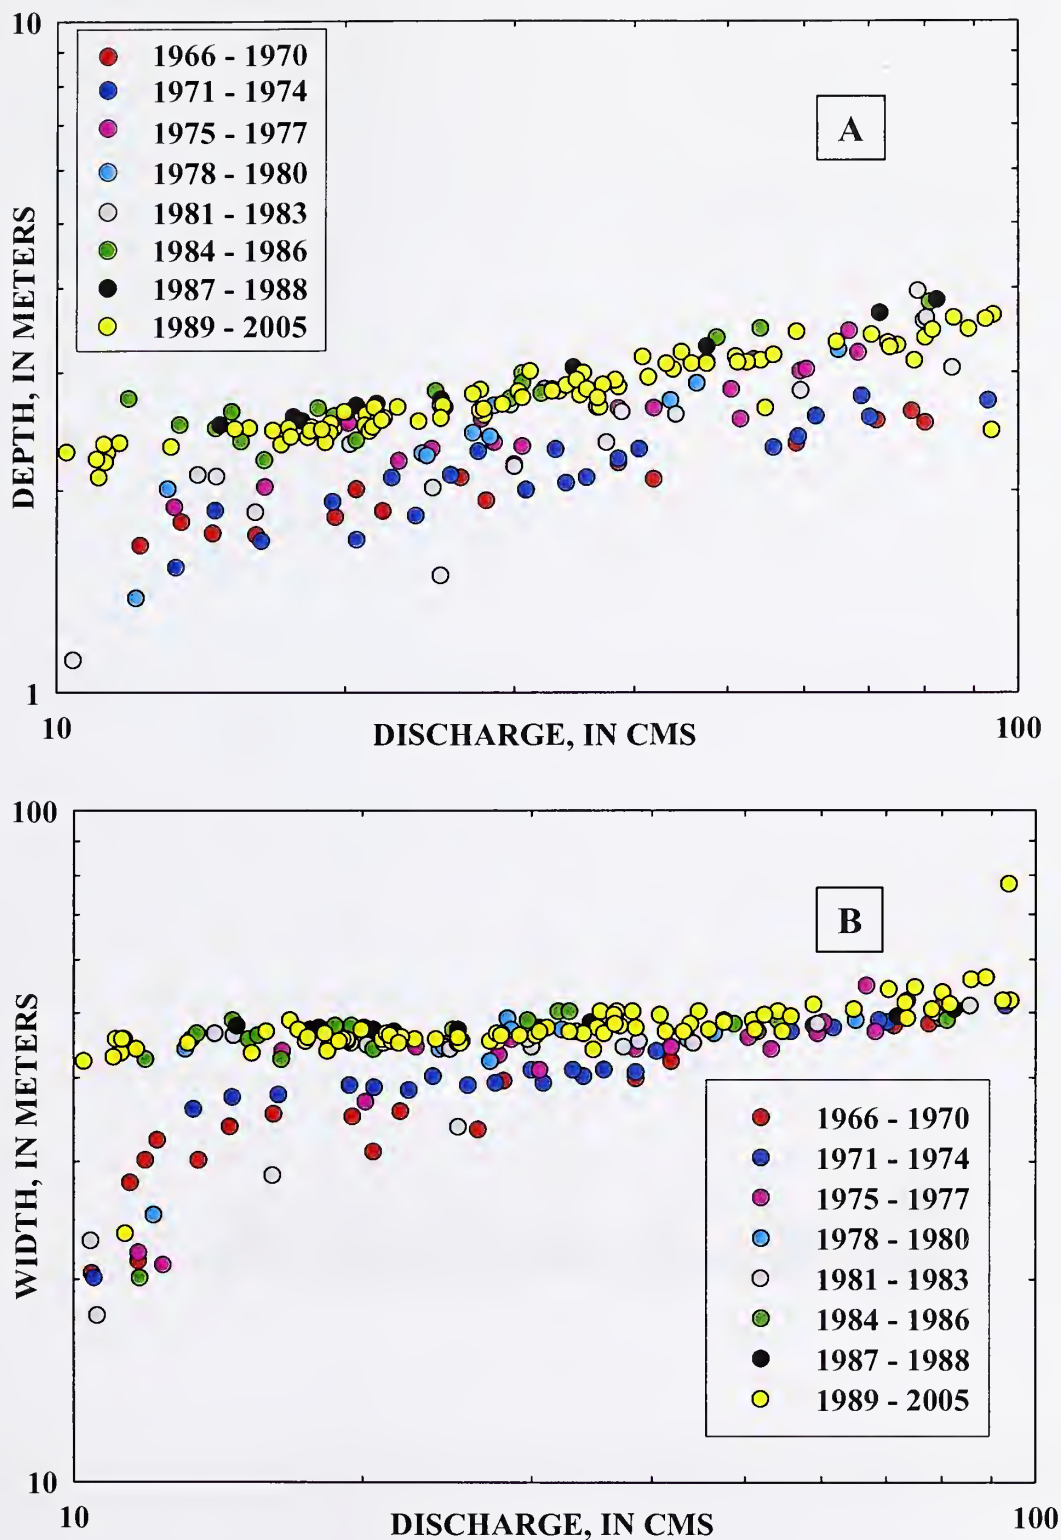
A plot of width-discharge for the time period on record indicates some widening of the channel at the location of the gage, particularly from 1975 to 1976, with width being fairly stable since then. This increase in top width occurred during the same period as the increase in hydraulic depth at this site, supporting the previous discussion of top-bank widening during the mid 1970's. Alternatively, the bridge may have been replaced (or modified) at this time (this would explain why the channel has not widened directly at the gage since 1976, even though channel widening has occurred extensively throughout the rest of reaches A and B since the 1981-1992 time period).

Figure 30 – A) Discharge-depth relation and B) discharge-width relation, for gage 02439400 (Buttahatchee River at Aberdeen), with data separated into different years to distinguish specific changes over time.

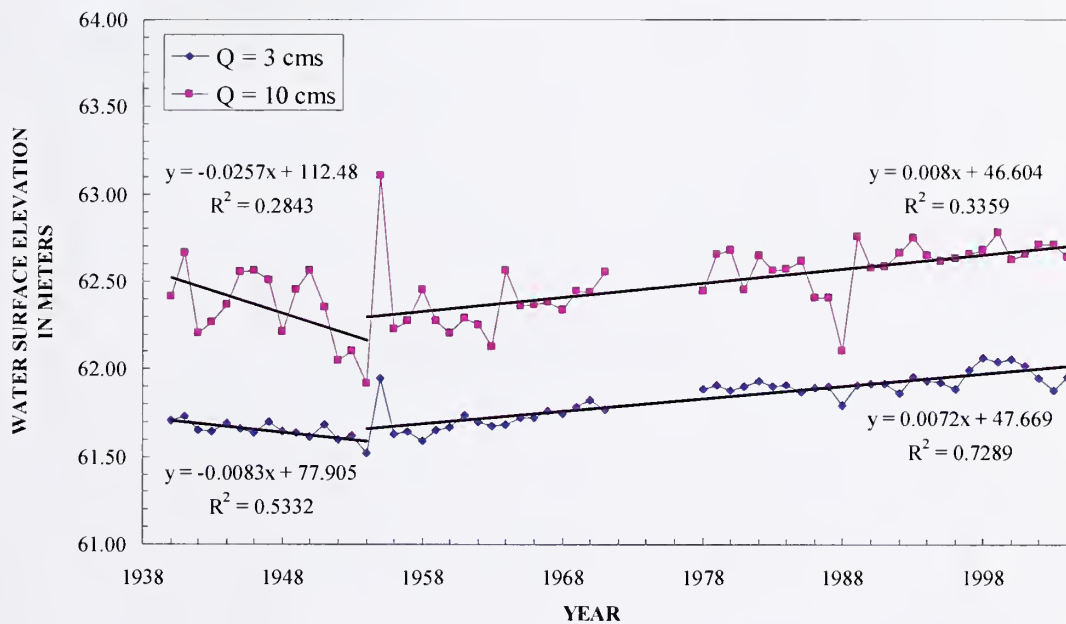
Except for a period in the mid-1970's when the gage was not operational, the record from this station represents the longest in the basin starting in 1939 and extending to the present. Specific-gage analysis at 3 and 10 m<sup>3</sup>/s shows a relatively consistent trend of mild aggradation (0.7 to 0.8 cm/y) since 1955 (Figure 32). Before this time, it seems that the river was experiencing mild downcutting. It is possible that the data from 1939-1954 are indicative of the attenuation of a downcutting phase that may signal a more intense period of incision and widening prior to installation of the gage. Although merely speculation, this period of incision may be the result of improved soil conservation measures and reduced sediment loads from upstream sources. These types of measures and consequent channel changes were common throughout the region and other areas of the Midwestern United States during this period.

Figure 32 – Specific gage analysis for gage 02446500, Sipsey River near Elrod.

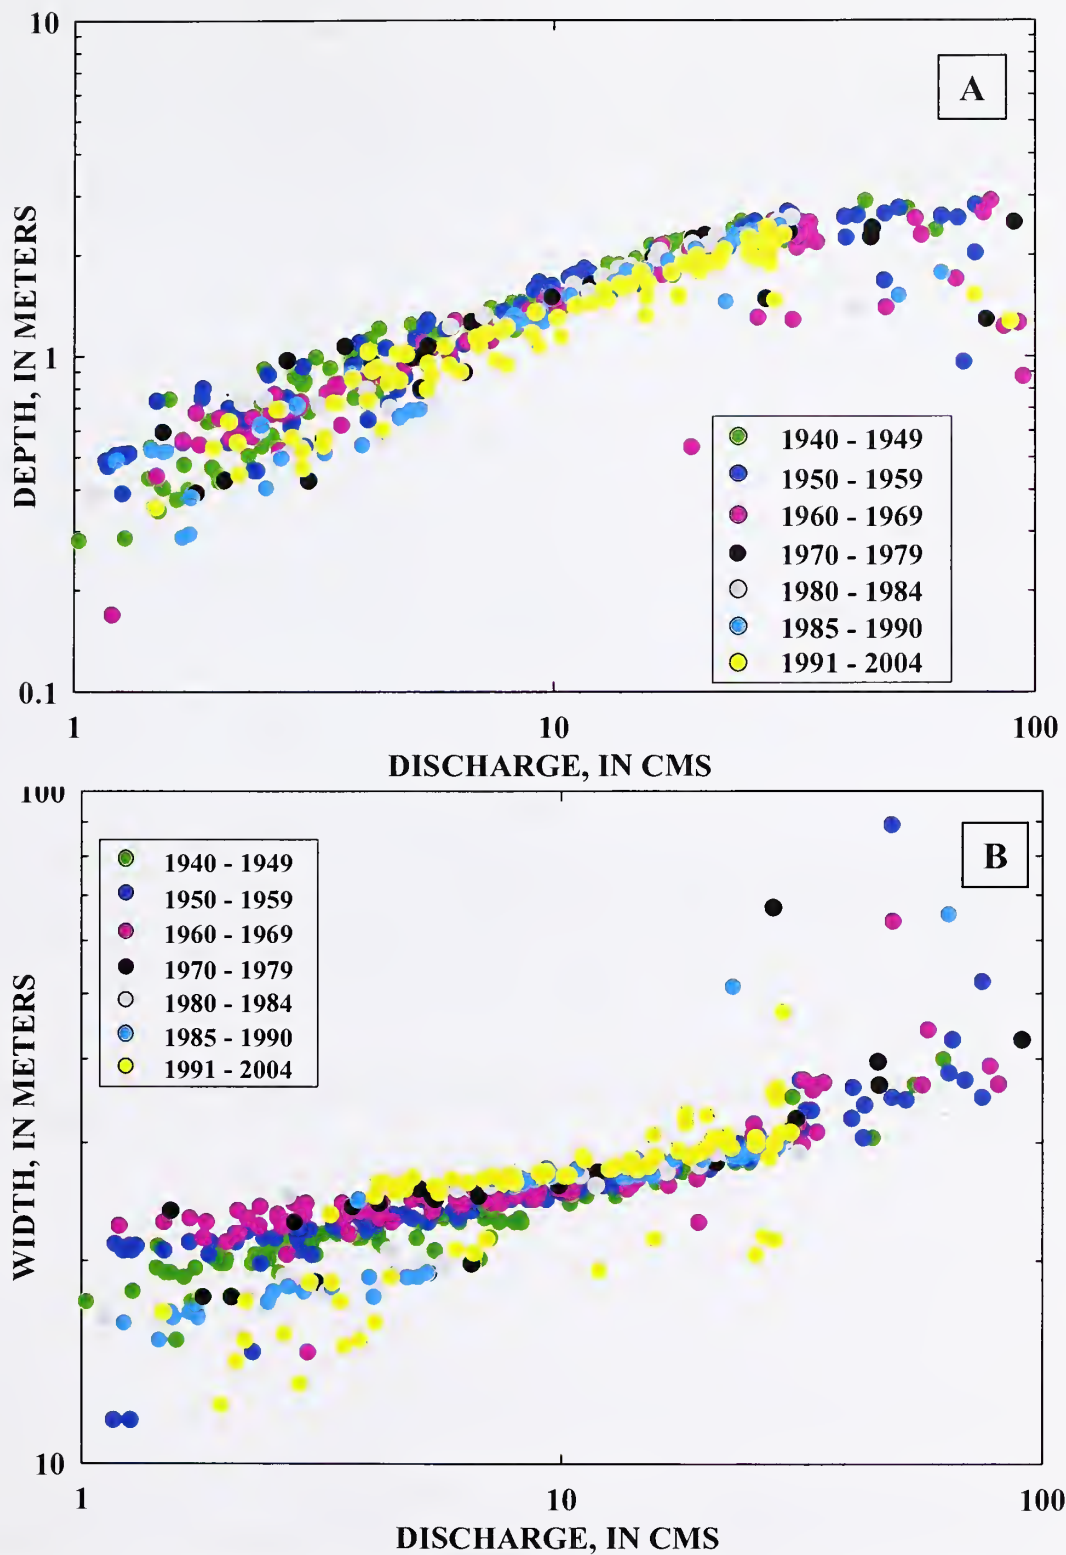
Trends of channel depth and width at specific discharges are generally supportive of the interpretations from the specific-gage analysis. Channel width is shown to increase over the period with the rate of increase slowing for the latest periods (Figure 33B). This would be typical of streams that had undergone downcutting, resulting in widening and then aggradation of the bed during stage V. The reduction in widening rates occurred as aggradation became the dominant trend. Field observations taken along the lower end of the Sipsey River suggest that the sites studied are currently stable (stability indices less than 10), but that the channel appeared to have undergone a period of mass failures sometime in the past. Anecdotal evidence from local residents suggests that the Sipsey

Figure 33 - A) Discharge-depth relation and B) discharge-width relation for USGS gage 02446500, Sipsey River near Elrod separated into different time periods.

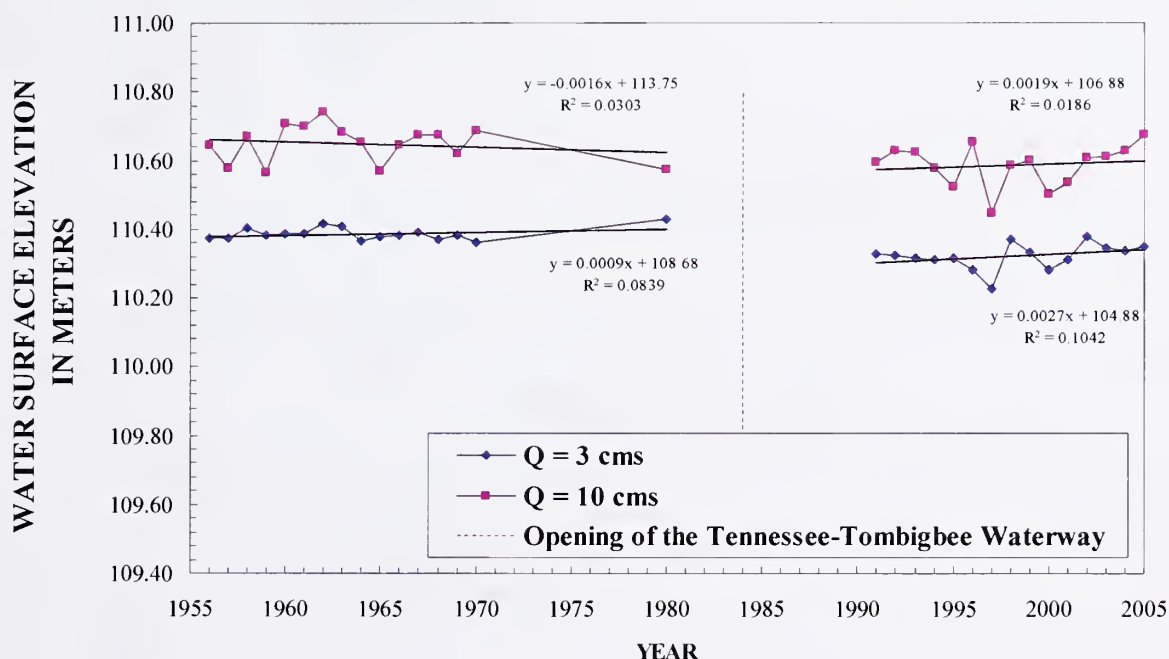
Specific-gage analysis for the gage below Hamilton (rkm 116.5), Alabama shows little change over the period of record (Figure 34). Splitting the data set into pre- and post-TTW (Figure 35) as well as shorter periods also showed no distinct changes over the time period (Figure 36).

**Figure 34 – Specific gage analysis for gage 02438000, Buttahatchee River below Hamilton.**
